Level 1, Platinum Reserve Analysis

Gateway Park Master Association

Gateway Park Blvd. & Mount Meeker Ave.
Berthoud, CO. 80513

Date of Property Observation – January 23, 2019

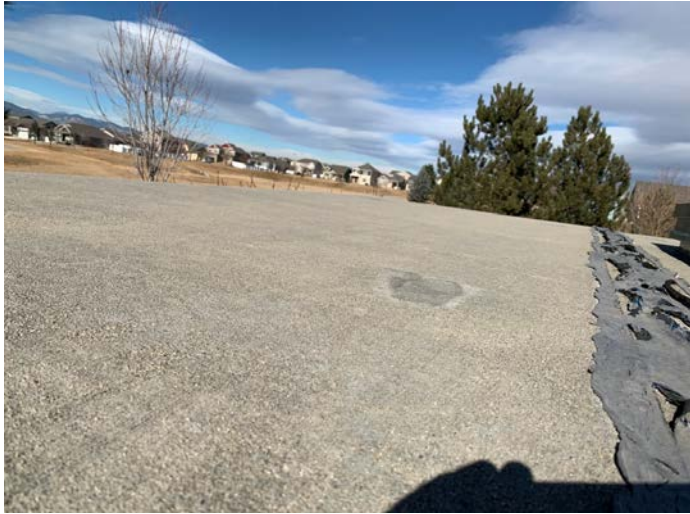
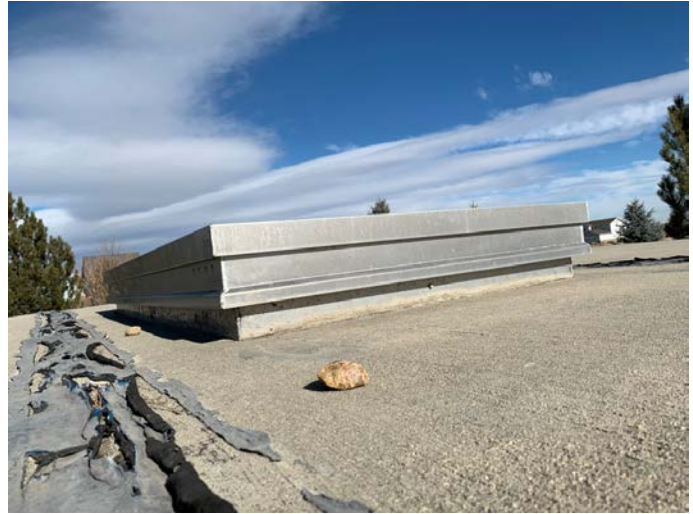
Comp #: 103 Flat Roof - Replace

- The roof appeared to be in fair to poor condition at the time of the site observation, with no issues reported.
- The average life for this type of roof ranges between 15 - 18 years, depending on quality of installation and roof materials.
- Remaining life is based on the age of the roof.

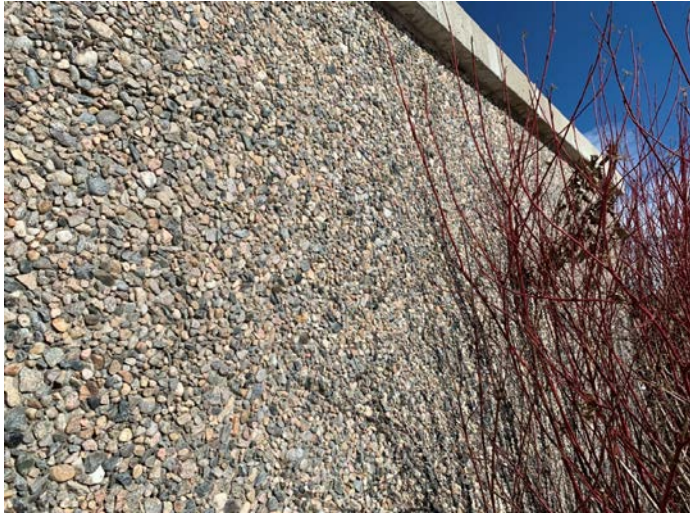
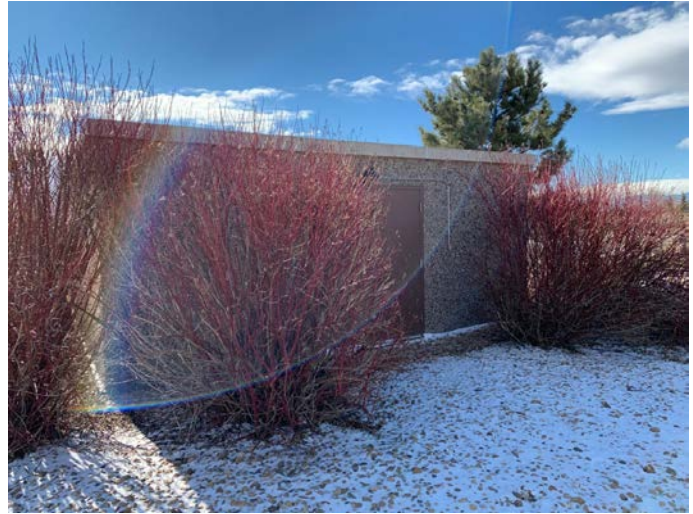
Comp #: 309 Stone/Rock Siding - Major Repairs

- No issues noted or reported with the walls of the pump house at the time of the site observation.
- This type of material has an extremely extended useful life and deterioration is very difficult to predict.
- No reserve funding is necessary for this component at this time.
- Continue to monitor conditions and adjust the report accordingly in future updates.

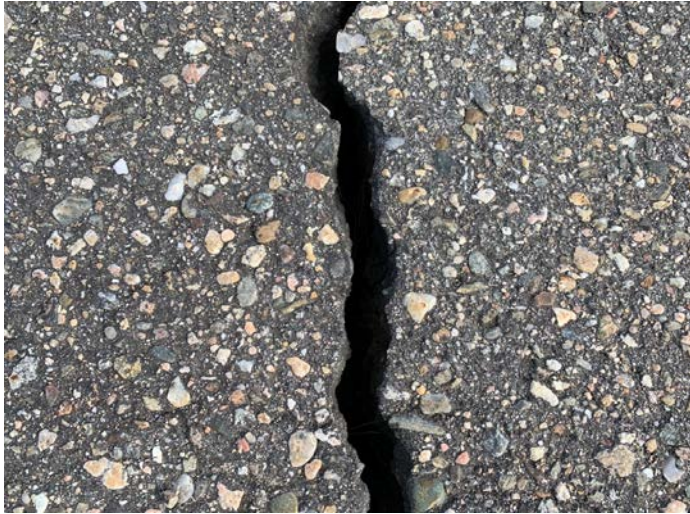
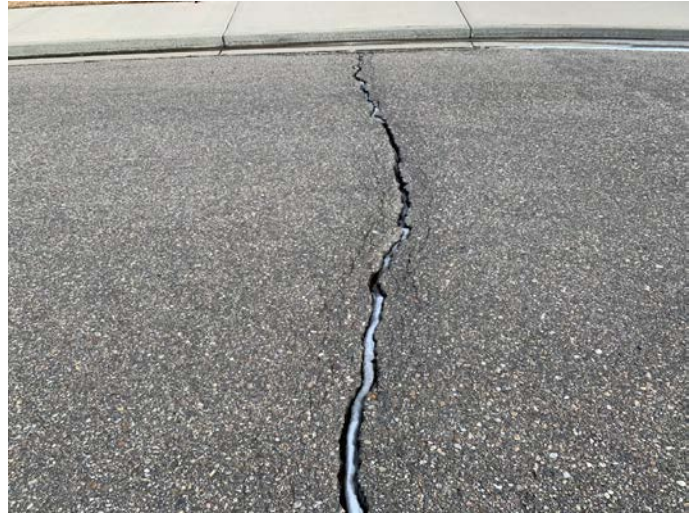
Comp #: 401 Asphalt - Major Overlay

- The asphalt parking lot had several very large cracks and other signs of deterioration at the time of the site observation.
- The average life expectancy for asphalt surfaces ranges between 20 - 24 years for surfaces that are maintained on a regular schedule.
- Maintenance includes crackseal and repairing small potholes annually as an operating expense.
- In addition, asphalt should be seal coated every 3 - 4 years, depending on the level of traffic and snow removing techniques.

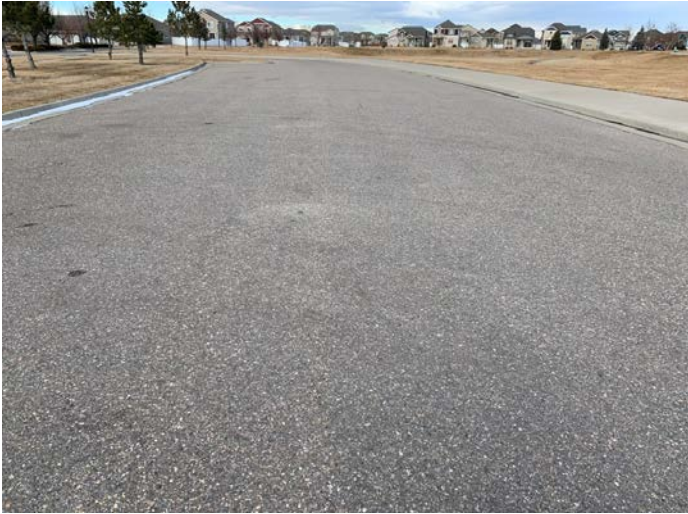
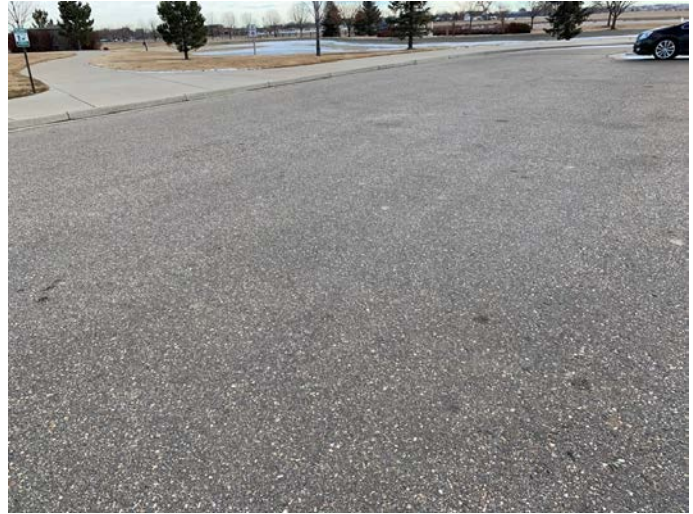
Comp #: 402 Asphalt - Surface Application

- The asphalt had several large cracks did not appear to have been sealcoated in some time.
- In this environment, expect to seal asphalt every 3 - 4 years, depending on traffic levels and effects from weather.
- Sealcoating is applied to protect the asphalt from ultra-violet rays and water.
- This helps in slowing the process of oxidation and raveling.
- While acting as a protective barrier, it also maintains the appearance of the community to maintain or improve property values.
- We have extended the useful life to allow for funds to be used on more pertinent projects.

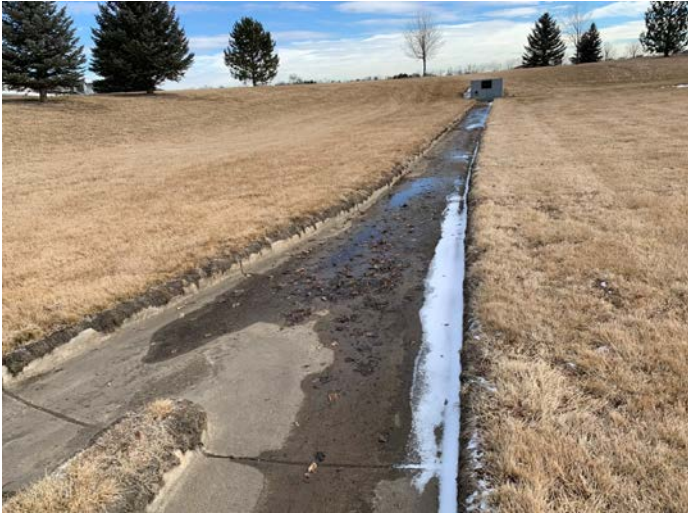
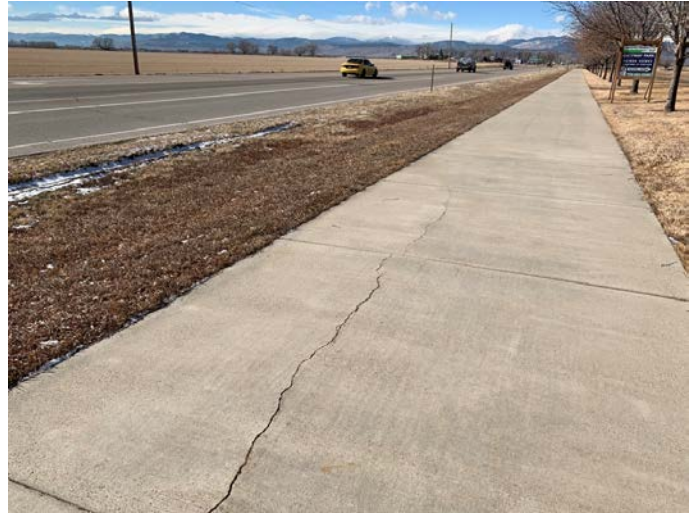
Comp #: 601 Concrete - Partial Replace

- The concrete throughout the property varied in condition, from very good to poor. There were several areas where trip hazards were noted. There were also some areas with cracks and spalling noted at the time of the site observation.
- It is unlikely that all concrete surfaces will fail and need to be replaced at the same time.
- Therefore, we suggest establishing a Reserve fund for frequent repairs and replacement to a percentage of the area (10% or 4,600 GSF) every 4 years.
- We have extended the useful life to allow for funds to be used on more pertinent projects.

Allowance to repair 10% of area every 4 years

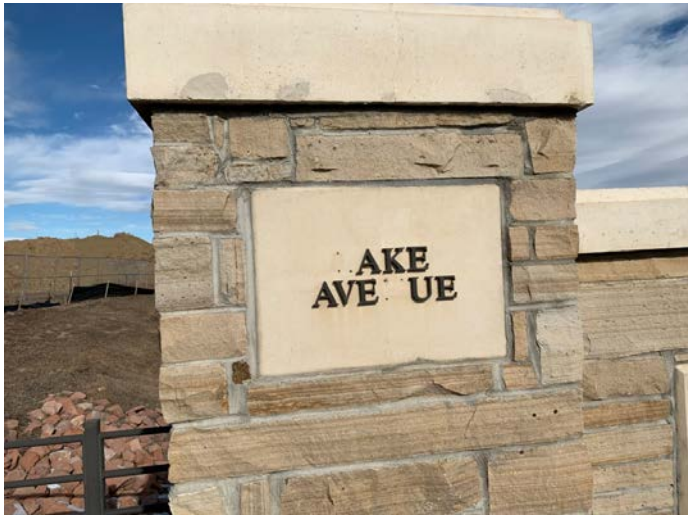
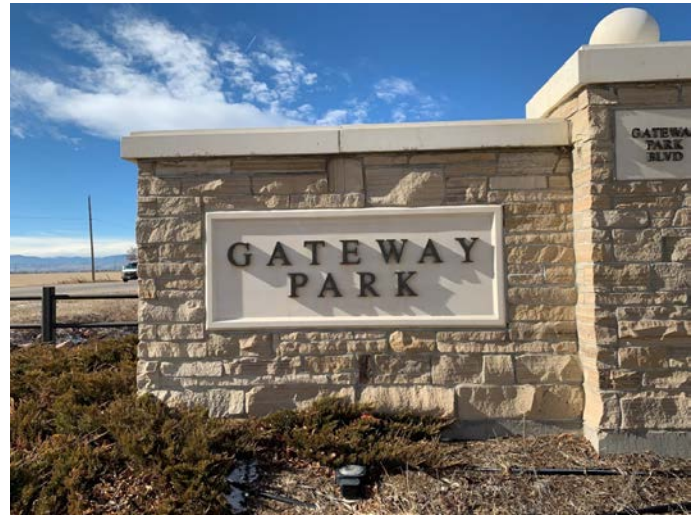
Comp #: 801 Monuments - Rebuild

- The structures of the monuments themselves were in good condition at the time of the site observation, and the signs were in fair conditions. There were some missing letters on the Lake Avenue monument.
- The materials used during construction have an extended life expectancy.
- While the structure should have an indefinite life expectancy, funding should be established for periodic upgrades and refurbishment of the signs and lighting, as well as repairs to the stone.
- Remaining life is based on the age of all monuments.

Allowance for general repairs

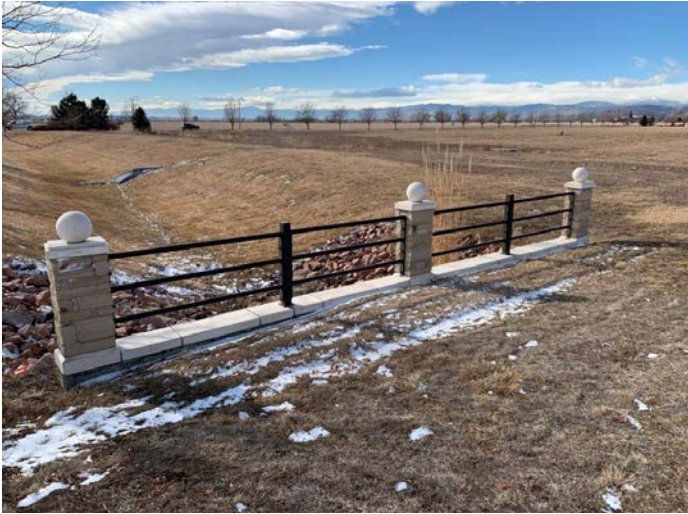
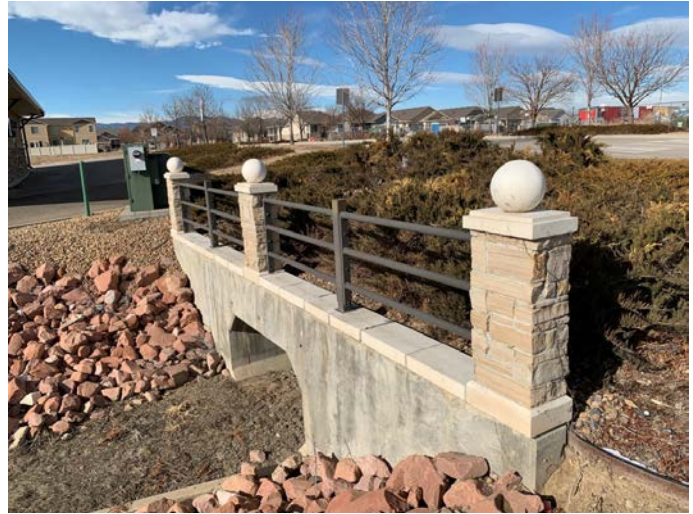
Comp #: 1009 Decorative Guard Rail - Major Repairs

- These decorative guard rails were in good to fair condition at the time of the site observation.
- Despite these materials having an extended life expectancy, we recommend reserving an allowance for major repairs to these areas every 18 years.
- The stone and the caps will deteriorate over time and will need to be repaired or replaced.
- The metal railing should be painted every 3 - 4 years out of the operating budget to protect the metal from the elements.
- Remaining life is based on the observed conditions.

Allowance for major repairs

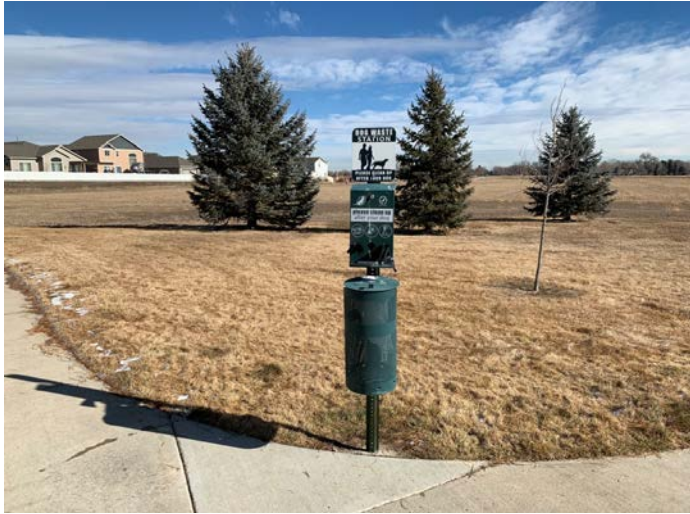
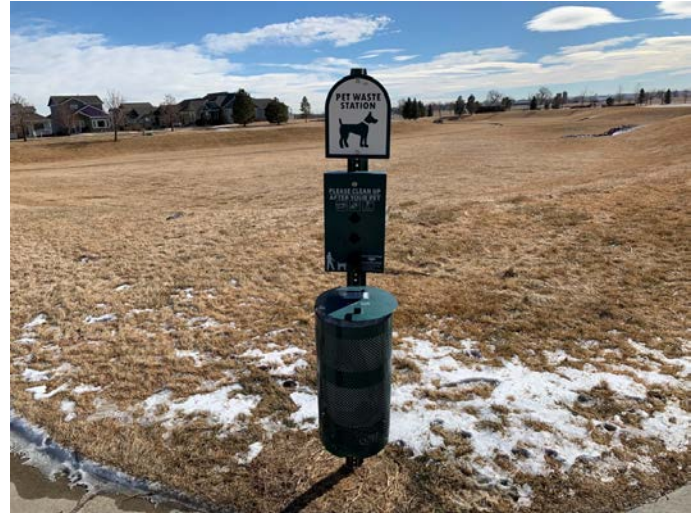
Comp #: 1311 Pet Waste Pick Up Stations - Replace

- Due to the low quantity, unlikely event that all will require replacement at the same time and the relatively low cost of individual replacement, we do not recommend reserving for replacement at this time.
- Maintain and replace on an as needed basis using operating funds.

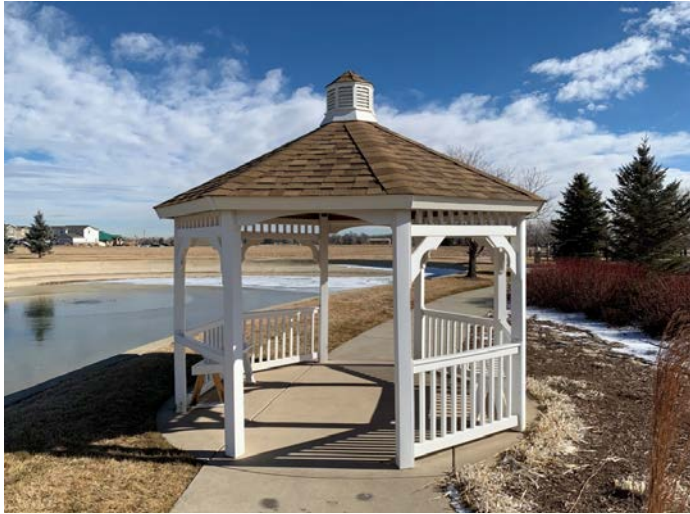
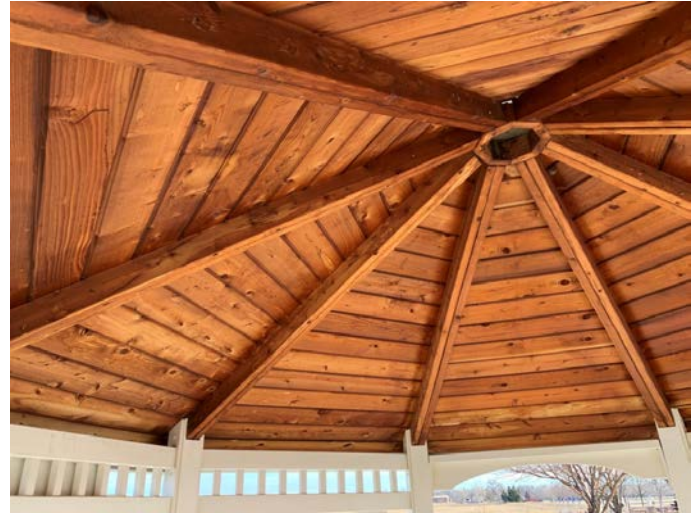
Comp #: 1320 Gazebo - Replace

- There were several missing pickets on the gazebo at the time of the site observation and the roof was in fair condition.
- This line item is for the replacement of the composite shingle roof and the PVC around the structure.
- Expect to replace these components approximately every 20 years.
- Remaining life is based on the current condition of the structure.

Estimate to replace

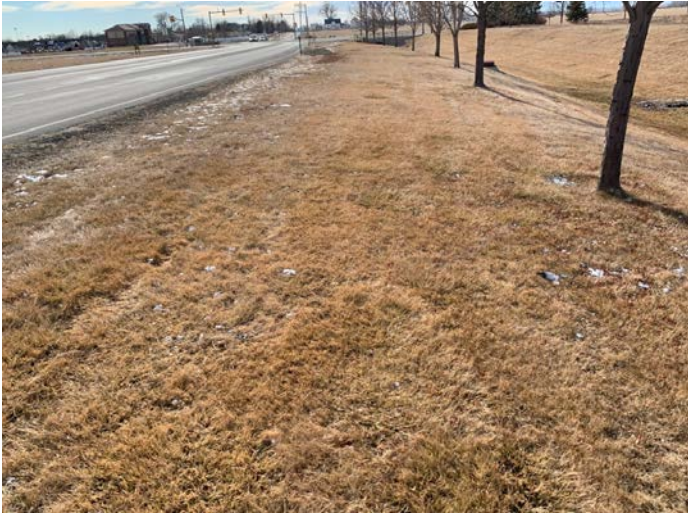
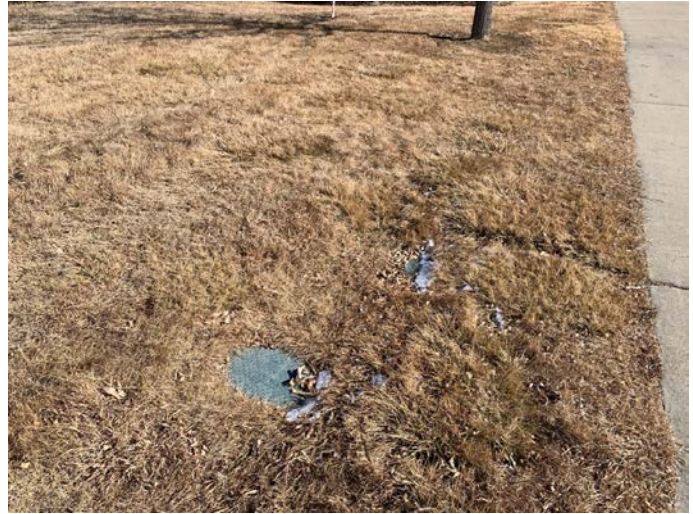
Comp #: 1701 Irrigation System - Major Repairs

- This line item is for repairs and replacement that lies outside the scope of routine maintenance: bulk sprinkler head replacement, bulk valve replacement, rerouting lateral lines, rewiring, etc.
- In order to ensure the funds are available for major repairs, we recommend reserving funds for these projects every 4 - 5 years.
- The funding on this line item is for major repairs and is not to be interpreted as complete irrigation system replacement.

Allowance for major repairs

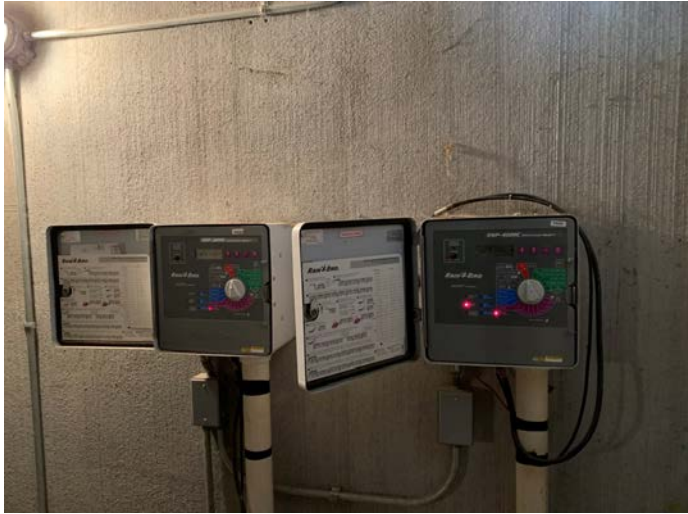
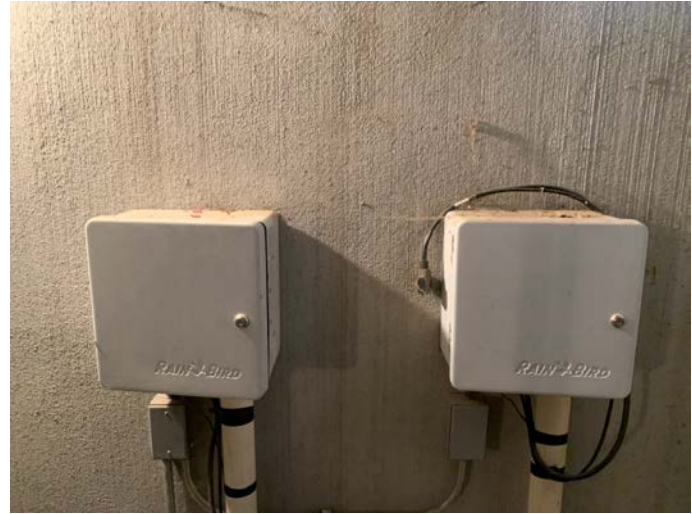
Comp #: 1703 Irrigation Controllers - Replace (1)

- These controllers are nearing the end of their typical useful life.
- Expect to replace irrigation controllers every 10 - 12 years if properly maintained and under normal conditions.
- Funding is for replacement with a similar controller.
- Remaining life is based on the age of the controller.

Estimate to replace with a similar controller

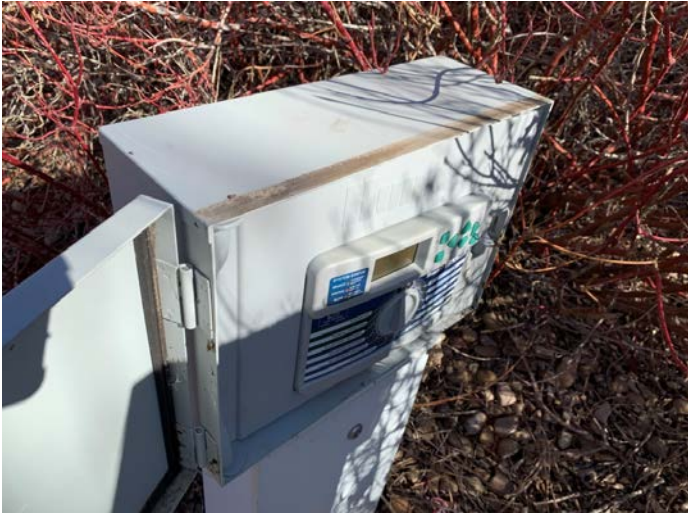
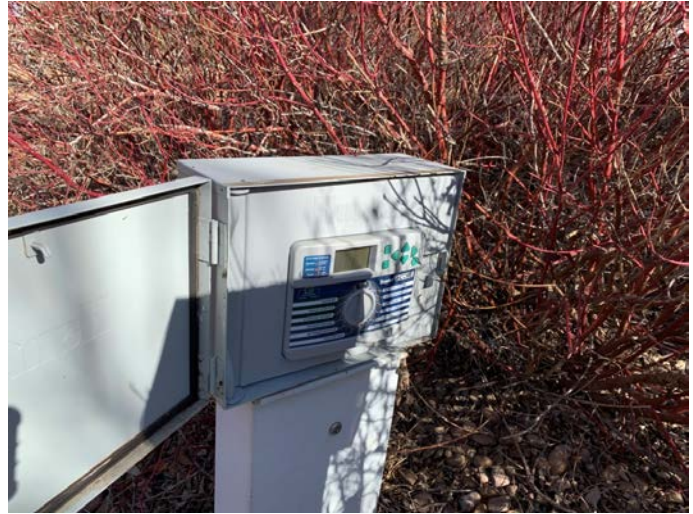
Comp #: 1704 Irrigation Controllers - Replace (2)

- Expect to replace irrigation controllers every 12 - 15 years if properly maintained and under normal conditions.
- Funding is for replacement with a similar controller.
- Remaining life is based on the age of the controller.

Estimate to replace with a similar controller

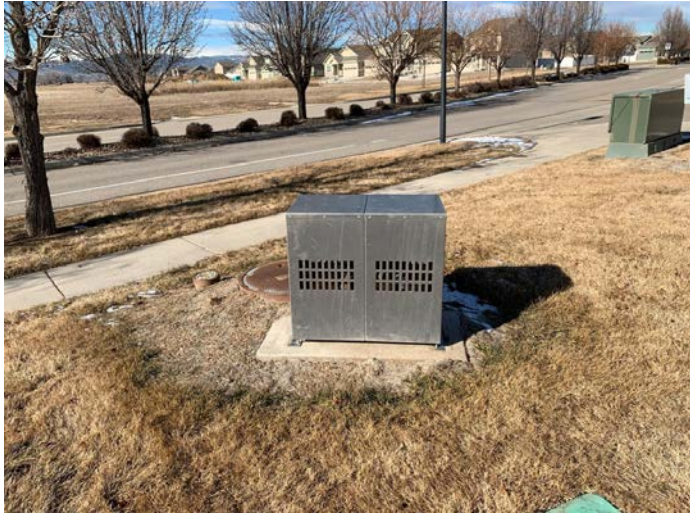
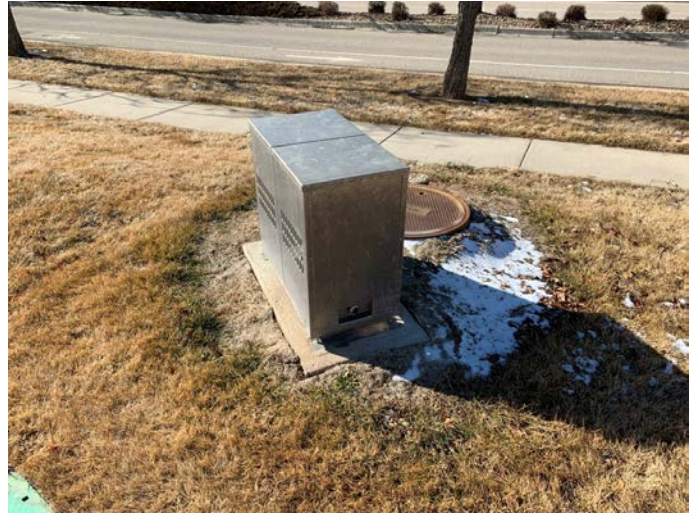
Comp #: 1706 Backflow Devices - Replace

- Devices can be rebuilt and repaired when needed as a maintenance issue.
- It is very seldom that a complete system would need to be replaced due to normal wear and tear.
- Replacement would be as a result of freezing conditions if system is not winterized properly or in a timely manner.
- No Reserve funding is required due to difficulty of predicting a life expectancy and the fact that systems can be rebuilt at a minimal cost, as opposed to being replaced.

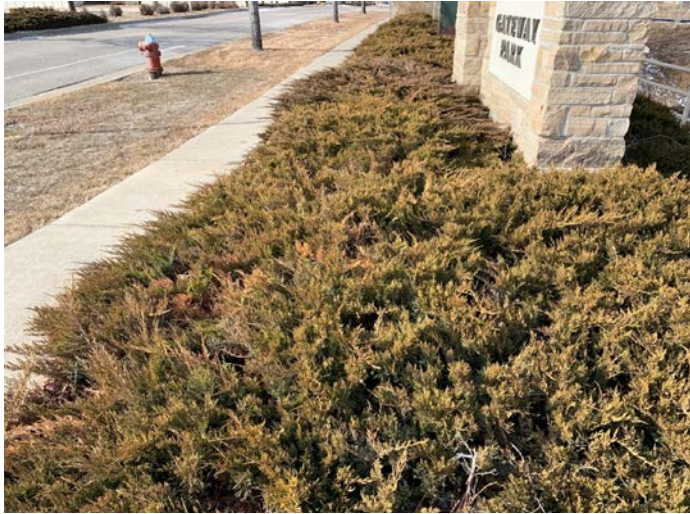
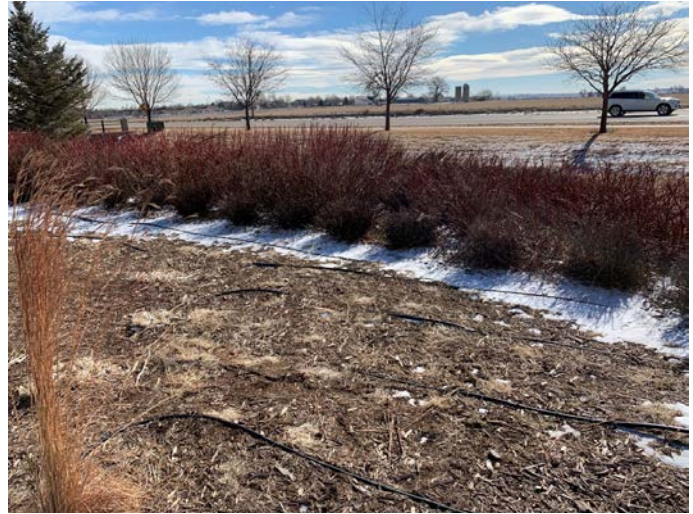
Comp #: 1801 Groundcover - Replenish

- There were several areas where the groundcover was worn-down and in need of some replenishment.
- This line item, similar to irrigation repairs, is for projects that lie outside the scope of routine maintenance.
- In order to preserve an attractive curb appeal and to maintain the health of the plants and shrubs, we recommend reserving for refurbishment projects every 2 - 3 years.
- This line item is for cyclical refurbishment and should not be considered as complete landscaping replacement.

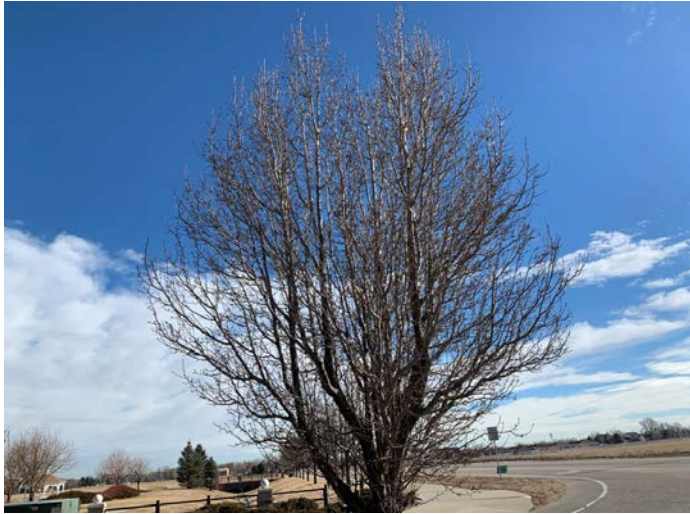
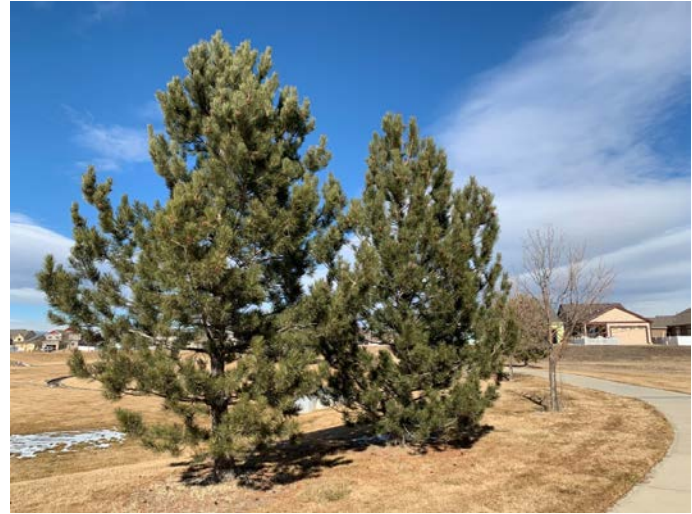
Comp #: 1804 Tree - Replacement/Major Maintenance

- It is very difficult to predict a replacement cycle for trees as there are several factors such as disease, infestation of insects, heavy snow storms, etc. can all attribute to eventual tree replacement.
- Since it is difficult to predict when the replacement will be necessary, Reserve funding is typically not a factor.
- Therefore, unless requested by the association, Reserve funding will not be included as part of the study for this component.

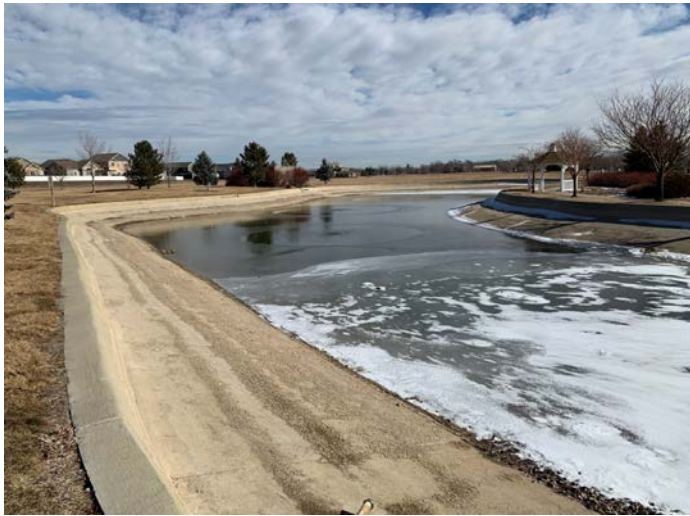
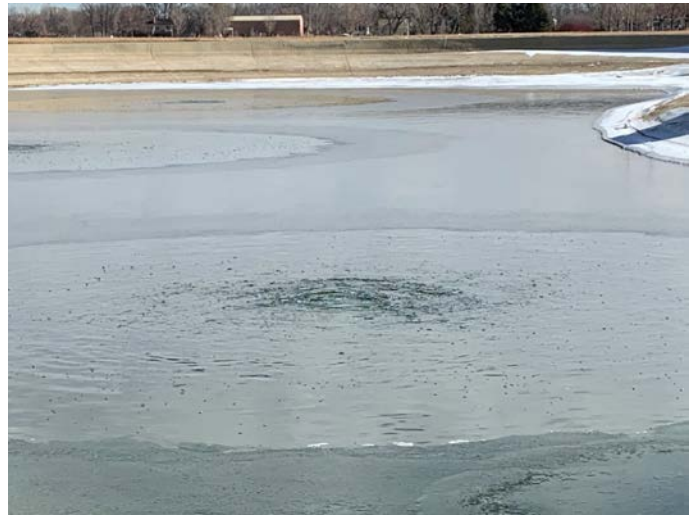
Comp #: 1807 Pond - Major Maintenance

- It was reported this pond was dredged in 2018 and was in good condition at that time.
- According to several local vendors, this should take place every 15 - 18 years to keep the pond in good condition.
- Remaining life is based on the timing of the last dredge.

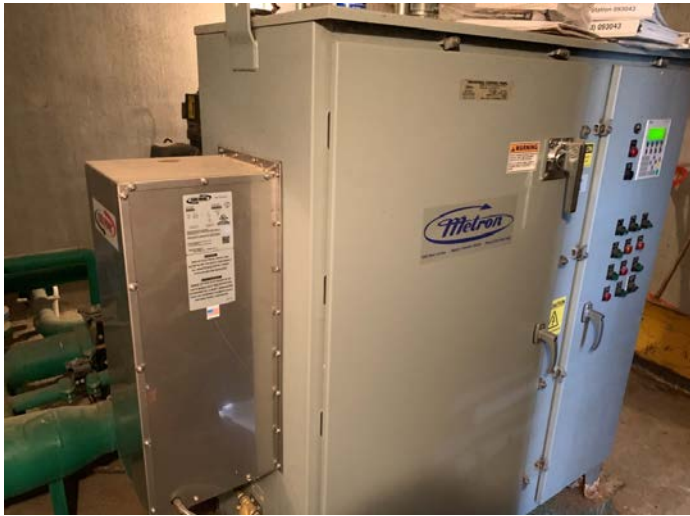
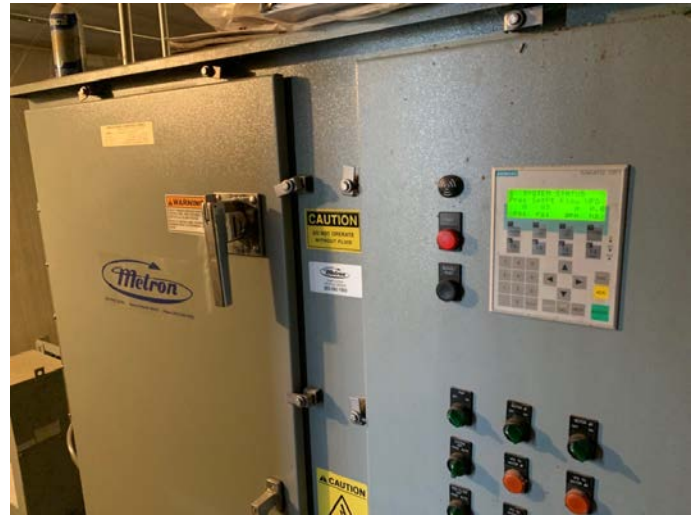
Comp #: 2001 Control Panel - Replace (Pump House)

- There were no reported issues with the control panel at the time of the site observation.
- This panel has a typical life expectancy of 20 - 24 years depending on the level of use and maintenance.
- Remaining life is based on the age of the panel.

Estimate to replace

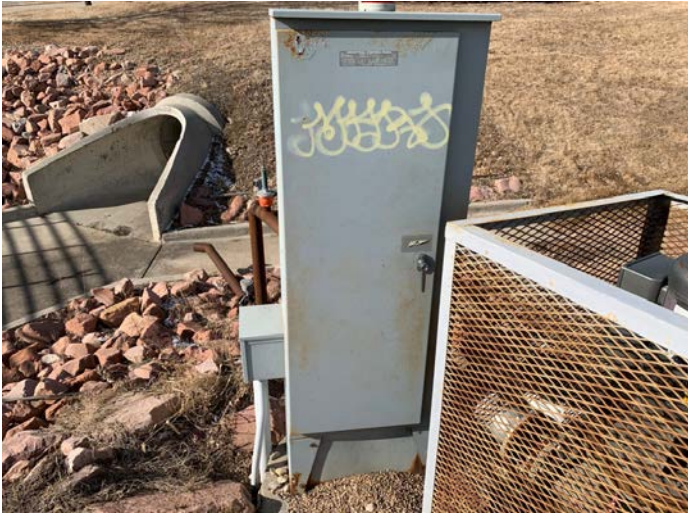
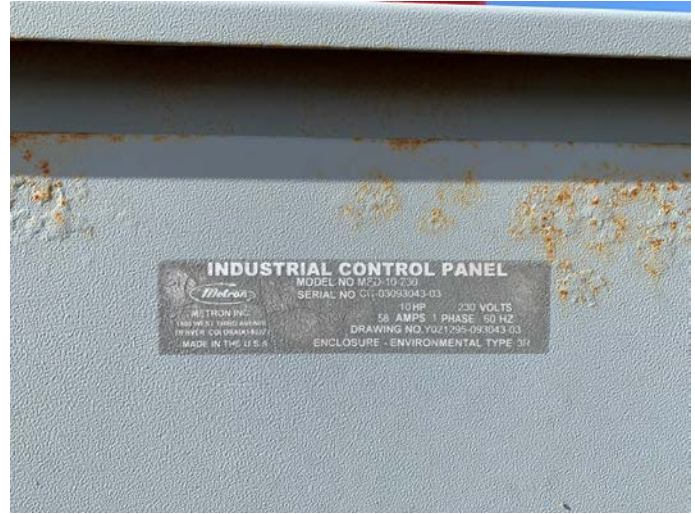
Comp #: 2002 Control Panel - Replace (Southeast Corner)

- There were no reported issues with the control panel at the time of the site observation.
- This panel has a typical life expectancy of 20 - 24 years depending on the level of use and maintenance.
- The useful life of this panel is shorter than the larger panel inside the pump house because it is exposed to the elements.
- Remaining life is based on the age of the panel.

Estimate to replace

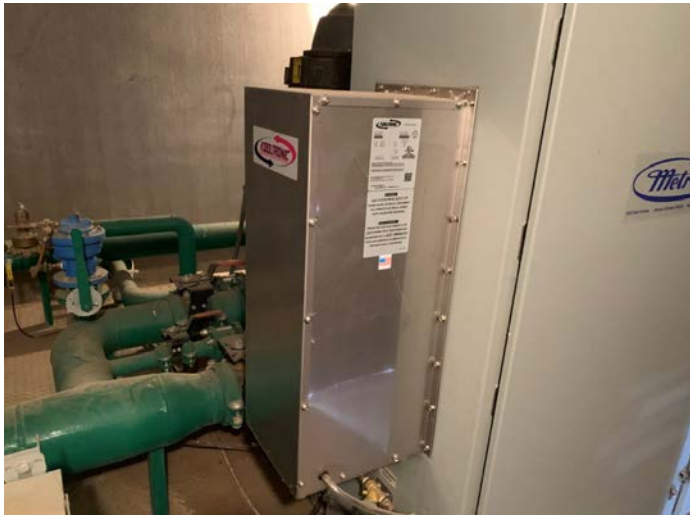
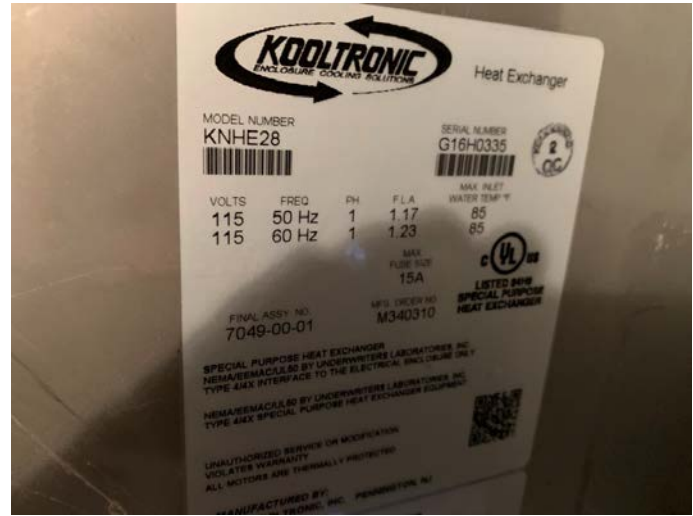
Comp #: 2003 Heat Exchanger - Replace

- This unit was replaced in 2017 due to failed piping within the cooler.
- Expect a useful life of 10 - 12 years from this component.
- Remaining life is based on the age of the heat exchanger.

Estimate to replace

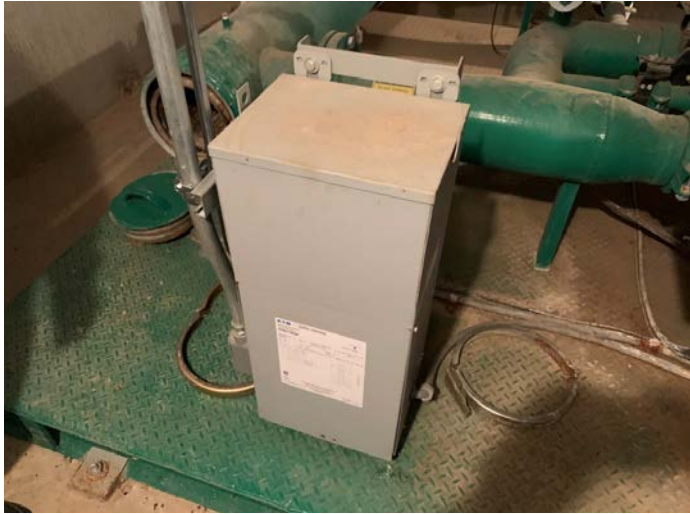
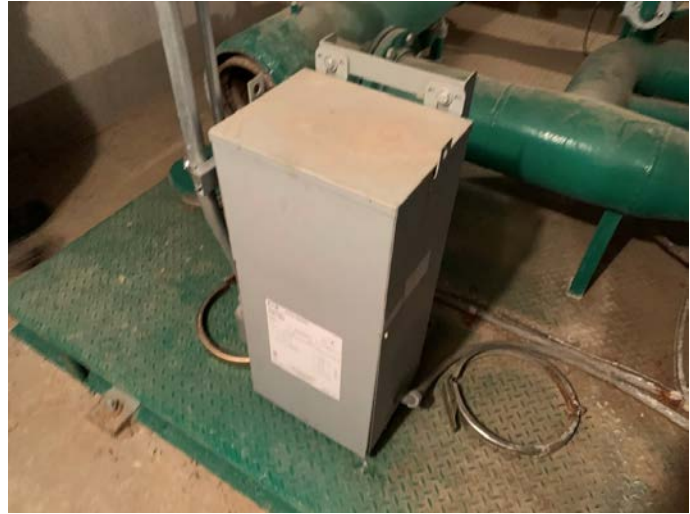
Comp #: 2004 Mini Power Center - Replace

- There were no reported issues with the mini power center at the time of the site observation.
- This unit can expect a useful life of 12 - 15 years if properly maintained.
- Remaining life is based on the age of the unit.

Estimate to replace

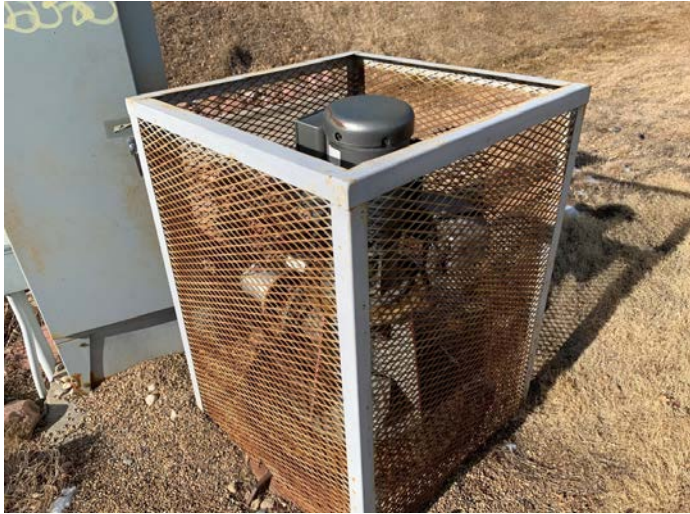
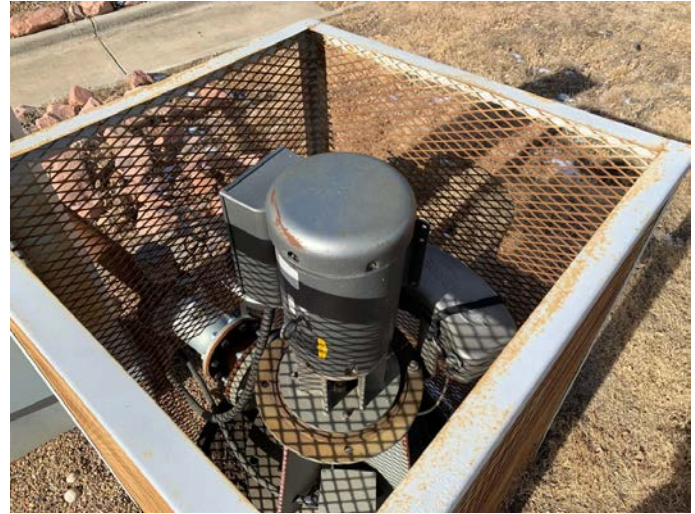
Comp #: 2025 Pump - Rebuild (Southeast Corner)

- It was reported that these pumps can be rebuilt instead of completely replaced. This should occur every 12 - 15 years depending on the maintenance and use.
- If the association properly rebuilds the motors and pumps every 12 - 15 years, complete replacement should be avoidable.
- Remaining life is based on the age of the motor/pump.

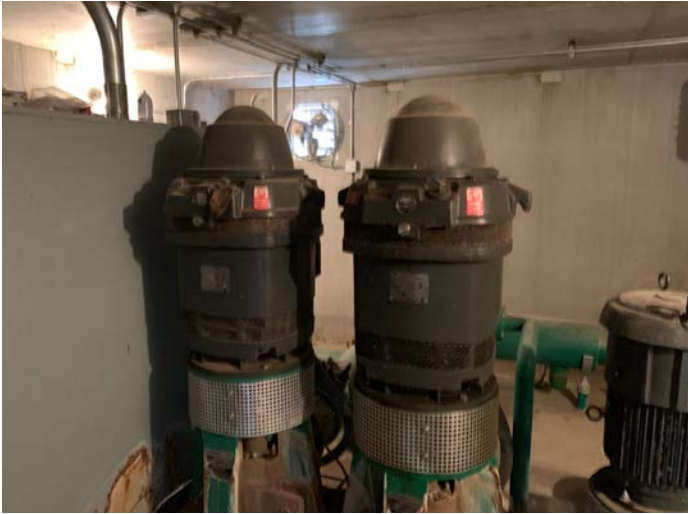
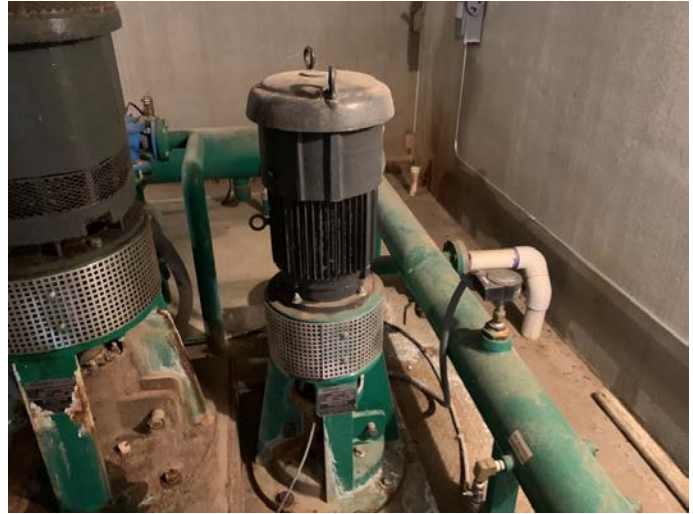
Comp #: 2025 Pumps - Rebuild (Pumphouse)

- It was reported that these pumps can be rebuilt instead of completely replaced. This should occur every 12 - 15 years depending on the maintenance and use.
- If the association properly rebuilds the motors and pumps every 12 - 15 years, complete replacement should be avoidable.
- Based on the age of the pumps and property, we recommend completing this rebuild during the current fiscal period.

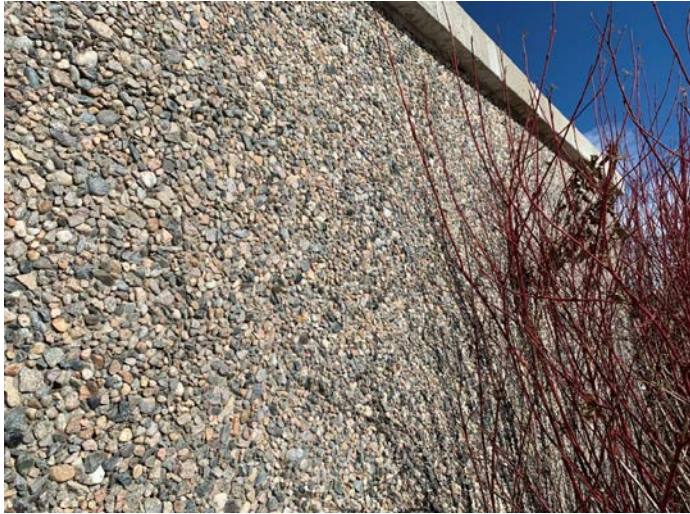
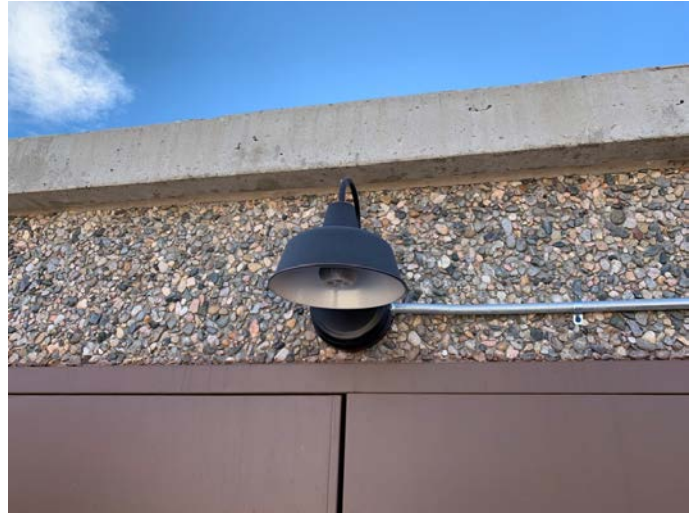
Comp #: 2035 Pump House - Replace

- The pump house building should have an indefinite life and repairs to the structure are unpredictable.
- The doors and light should be replaced as needed with operating funds.
- Continue to monitor conditions and adjust accordingly in future reports.
